# CPC-800 XLT: GPS Module Failures

© November 2018 David Craig<sup>1</sup> – neophyteastronomer.org

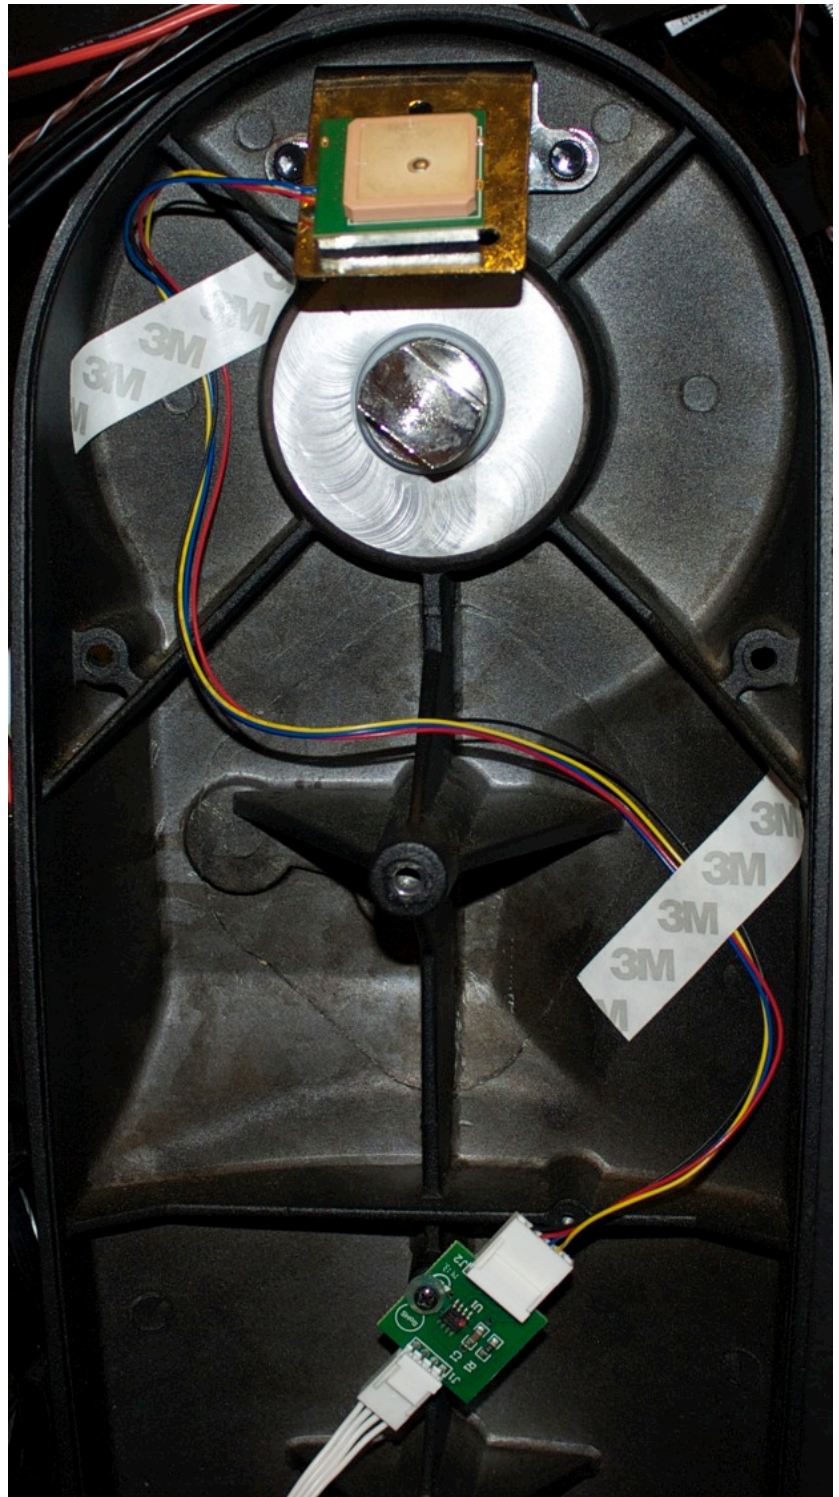
I found the GPS module easily enough after removing the plastic cover of the right fork arm (the one with the handle). There's also a small interface board in the fork arm. The GPS module is mounted on a metal bracket as seen near the top of the photograph.

The part of the GPS module that is pointing up in Figure 1 is the antenna that "sees" the satellites. There's a metal shield on the backside of the module, which is stuck to the shiny metal mounting bracket by extremely aggressive, double-sided foam tape. The bracket is screwed into the fork arm by plastic thumbscrews and held above the screw bosses by nylon washers.

**Figure 1 - The GPS module is located near the top of the right fork arm (the one with the handle). The beige square is the antenna. An interface module is also visible.**

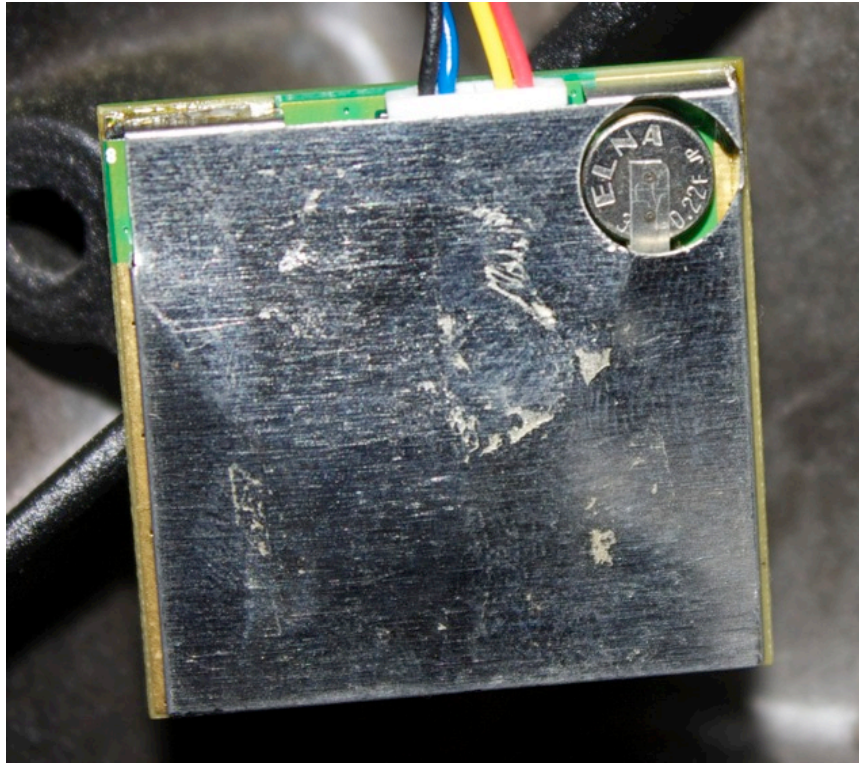
Figure 2 - Shielded side of the GPS module. The super-capacitor is near the cable connector. The markings “0.22F” indicate that this is a capacitor – not a battery. The solder tab obscures some of the markings. A stock photo of the capacitor is also shown for reference.

There’s a hole in the shield through which the “battery” is clearly visible. But as I said, the “battery” isn’t a battery at all. The markings - “3.3v 0.22F” indicate the part is actually a 0.22 *Farad* capacitor with a maximum voltage rating of 3.3 volts.

I measured the capacitors voltage with no power applied to the telescope before proceeding. It was about 2.9 volts. In retrospect – that seems like a reasonable value to sustain the GPS memory. But I had no schematic, little else to go on, and nothing to lose by replacing the capacitor.

The capacitor markings were sufficient to order a suitable replacement from Digi-Key Electronics ([www.digikey.com](http://www.digikey.com)). The replacement part is an Elna America DCK-3R3E224U-E, Digi-Key part number 604-1007-ND, and cost less than two dollars (exclusive of shipping).

At this point replacing the capacitor was really a shot in the dark – but it worked! The CPC-800 started behaving normally again. I measured the voltage across the new capacitor, and it was still about 2.9 or 3 volts. Odd – no significant change? Anyhow, I was happy and considered this “case closed”!

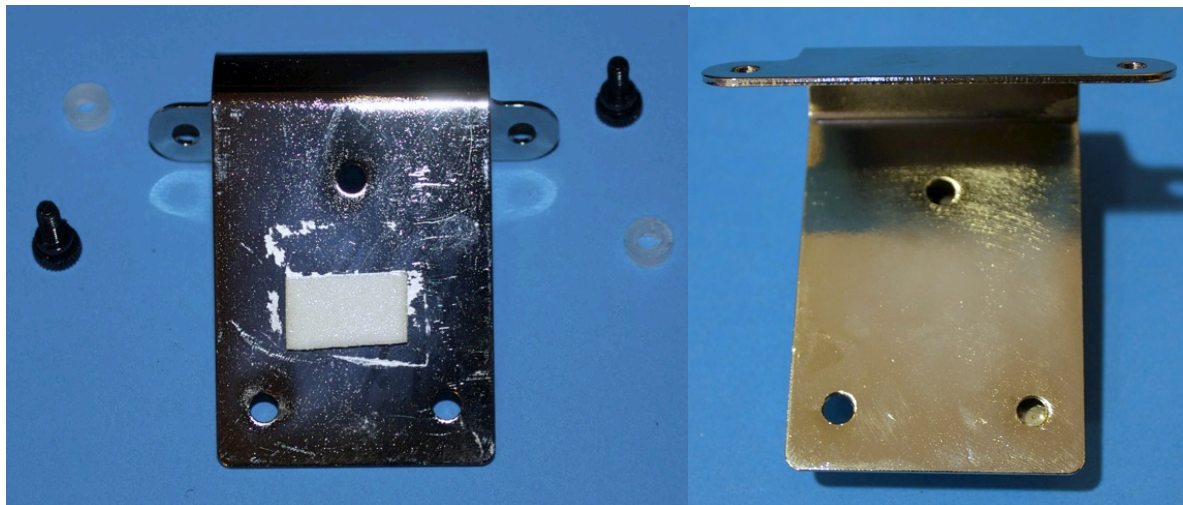
Figure 3 – On the left: mounting bracket with a small piece of new double-sided mounting tape, ready to accept the GPS module. The plastic thumbscrews and nylon washers for securing the bracket are also shown. On the right: the bracket is seen from the rear after reattaching the GPS module. Notice, the capacitor is visible through the lower-right hole in this photograph.

When I stuck the GPS module back to its bracket with new mounting tape, I noticed that the bracket had several holes, one of which could be aligned with the hole in the GPS shield. I thought that by aligning these holes I would have the future ability to easily contact the capacitor without removing the GPS module from the shiny metal bracket at all, and this paid off later!

Re-attach the GPS receiver to the mounting bracket using new double-sided foam mounting tape. When you do – align the hole in the GPS shield with the hole in the mounting bracket so you won't need to unstick the GPS from its mounting bracket in the future. I see no need to use a giant piece of mounting tape. A small piece will do as in Figure 3.

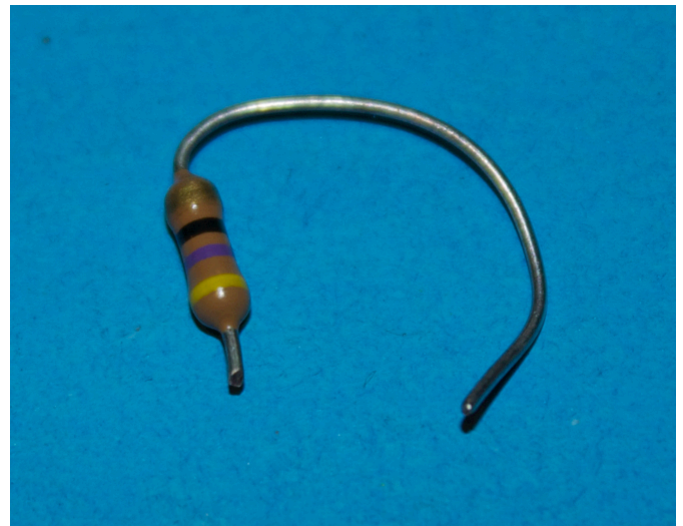
Figure 4 – A suitable axial-lead resistor. This one is 47 ohms, 1/4 watt.

Cut one lead of the resistor very short – 1/8". This is the end that will touch the capacitor. Leave the other end uncut and bend it roughly as shown in Figure 4. This end will touch the GPS module shield. The resistor body then serves as an insulator making it difficult to accidentally short-circuit the capacitor directly to the shield.

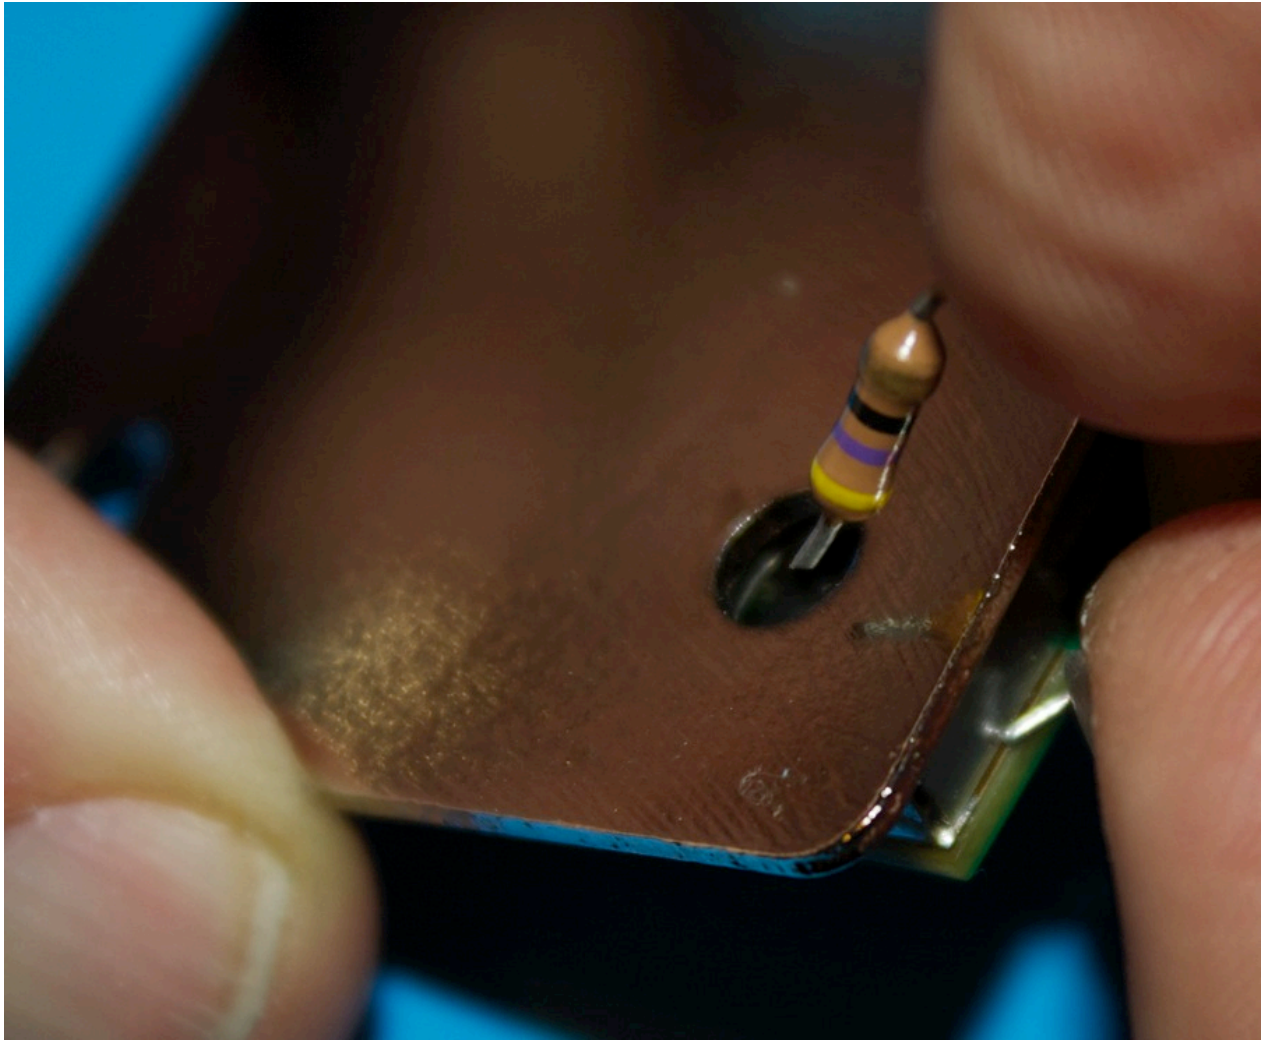
**Figure 5 - Discharging the capacitor.** In this photograph, the capacitor is accessed through a hole in the mounting bracket, but initially it may be necessary to remove the GPS module from the bracket in order to contact the capacitor. Note, the mounting bracket and the shield are not connected. The resistor must contact the GPS shield.

I held the 47-ohm resistor across the positive side of the capacitor and the GPS shield for about 30 seconds for good measure (the negative end of the capacitor is connected to the shield in this GPS module, so the resistor is effectively across the capacitor). Eureka! Upon sticking the GPS module back on its bracket and powering up the telescope (in my back yard with a clear view of overhead satellites), the GPS was up and running!

While holding the long end of the resistor lead touching the GPS shield, insert the short end through the hole in the shield to contact the capacitor. Hold the resistor in place for at least thirty seconds – being sure that the resistor ends are making contact to both the shield and the center of the capacitor. The resistor must contact the GPS shield, not the mounting bracket.
